LT-Corr

Low-temperature corrosion in biomass fired boilers

LT-Corr, 04/2015 – 12/2017, multi-firm

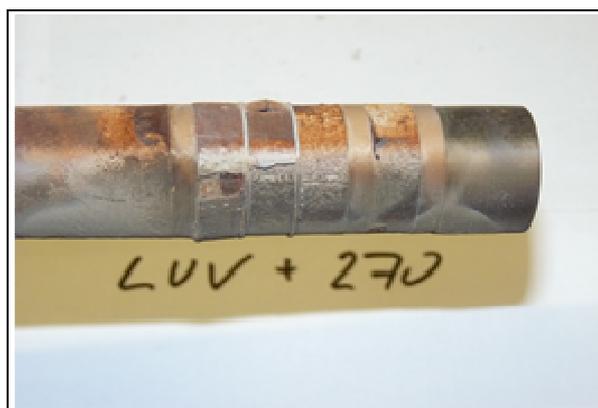
Fig. 1: Online corrosion probe after application in biomass heating plant (copyright: BIOENERGY 2020+)

Within the project affected biomass CHP plants and biomass heating plants are examined on site. By using a newly developed low-temperature online corrosion probe, the exact parameters influencing the occurrence of corrosion are determined. In addition, a comprehensive analysis of fuels, condensates and ash

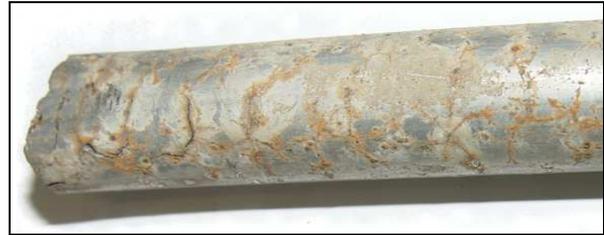
Fig. 2: Corroded heat exchanger tube
(copyright: BIOENERGY 2020+)
